**FINAL REPORT  
ROUND 10 DAM ASSESSMENT  
PPL GENERATION, LLC.  
BRUNNER ISLAND POWER STATION  
ASH BASIN NO. 6 WITH POLISHING POND, EQUALIZATION POND AND  
INCIDENTAL WASTE TREATMENT BASIN (IWTB)  
YORK HAVEN, PENNSYLVANIA**

**DECEMBER 20, 2012**

**GZA GeoEnvironmental, Inc.  
One Edgewater Drive  
Norwood, Ma 02062  
GZA File No. 01.0170142.30**

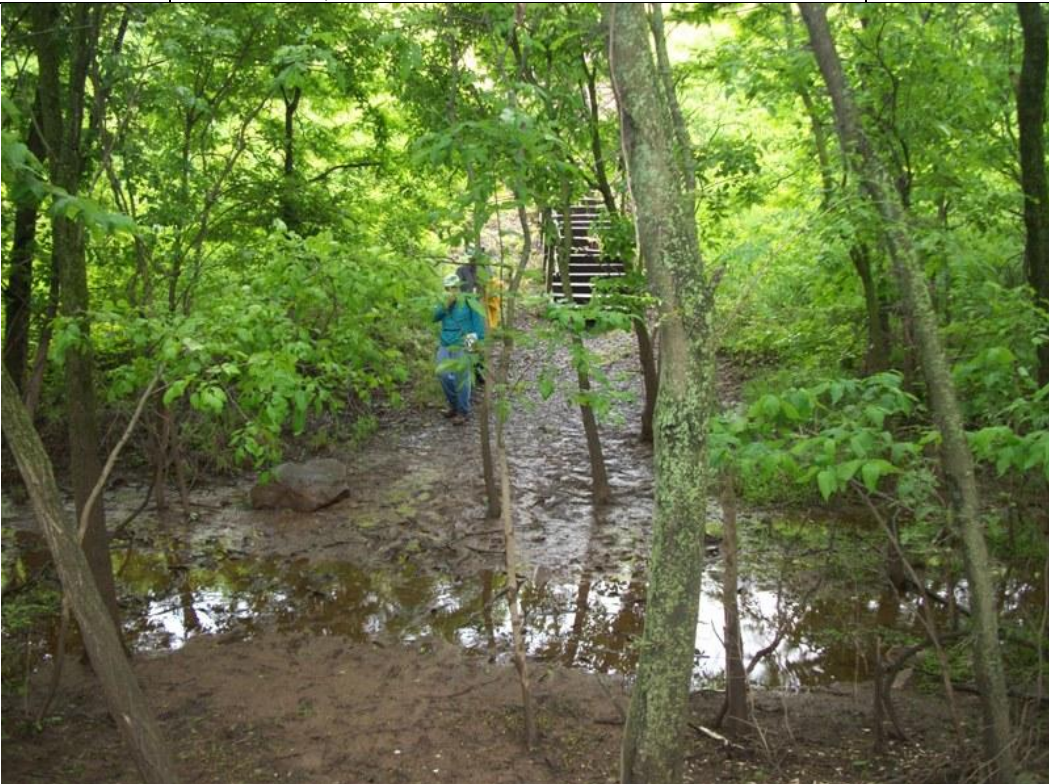
<b>Direction Photo Taken:</b> Westerly			
<b>Description:</b> Standing water observed just beyond toe of east side embankment. According to Plant Representatives this water is likely remnants of previous weeks flooding along the Susquehanna River.			
<b>Photo No.</b> 14	<b>Date:</b> 5/18/2011

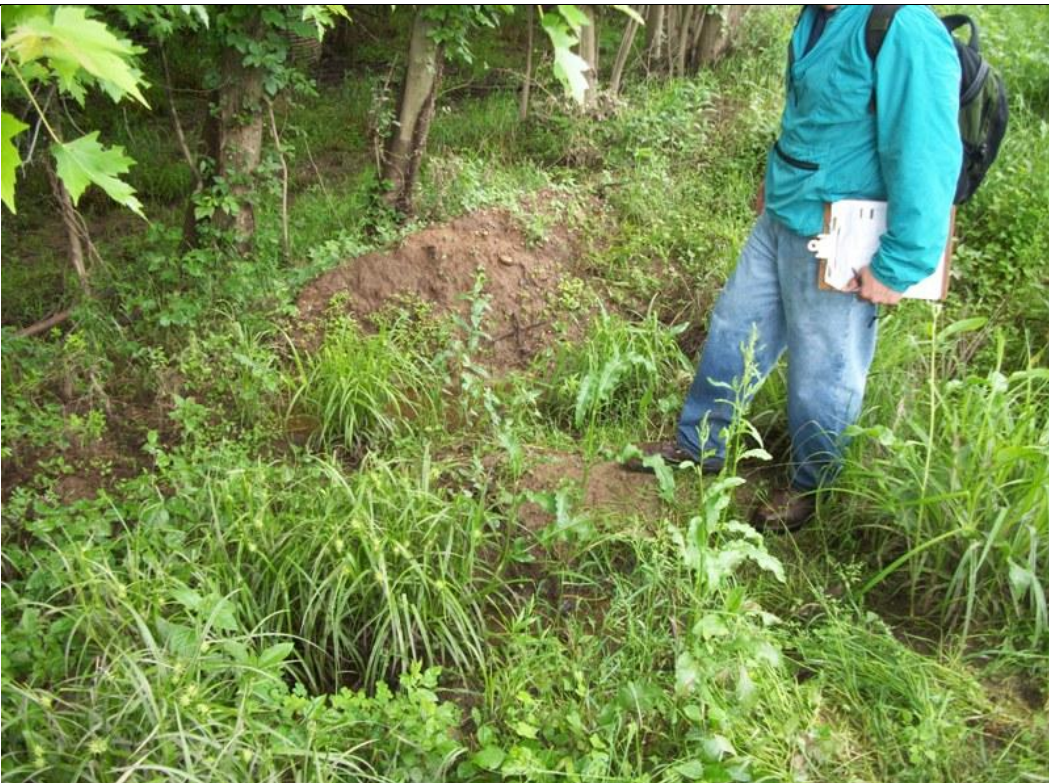
<b>Direction Photo Taken:</b> Southeasterly			
<b>Description:</b> Localized scarp/erosion observed near toe of embankment on the east side.

1. Repair sloughs and scarps on the embankment and provide future erosion protection as necessary.
